Executive Summary

On Sunday, June 30, 2002, a wildland fire was reported on Bureau of Land Management (BLM) land 14 miles northwest of Price, UT. The initial attack response included a type III incident commander, several fire engines, dozers, airtankers, a type III helicopter, and eight smokejumpers. When the incident commander (IC) and some of the engines arrived on the fire at about 1500, the fire was about 25 acres and growing rapidly. Extremely dry fuels, moderate winds, steep slopes, and deeply dissected drainages all indicated the potential for extreme fire behavior. It was determined afterward that a passing railroad train had started the fire.

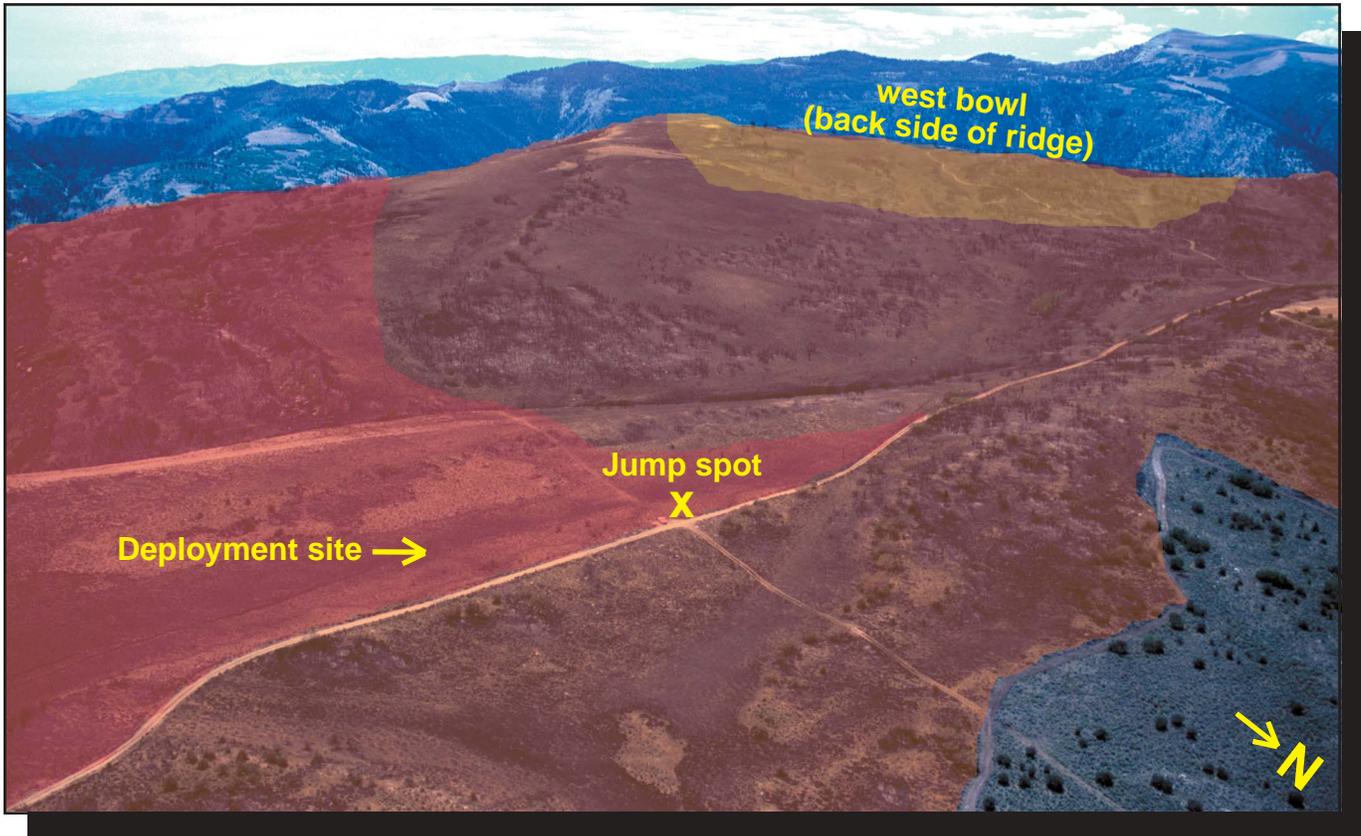
tersection. Initially, jumpers John Simas, Steve Reed, Jim Duzak, and Matt Loe began firing the south side of the road that headed east from the road intersection (figure 3). Jumpers Tom Dwyer and Pete Briant began firing the east side of the two-track road that headed south from the intersection. Tom Dwyer also served as a lookout for the jumpers' firing operation. JIC Orr and jumper Barry Burris remained near the jump spot. IC Garcia, who was now on a reconnaissance flight in helicopter 45Y, observed the jumpers' firing operation and told them he approved of what they were doing.

Figure 3—Fire events: RED is the area burned by jumpers; YELLOW is the fire emerging onto the plateau from the west bowl on the back side of the ridge; and BROWN is the fire after column collapse occurred.

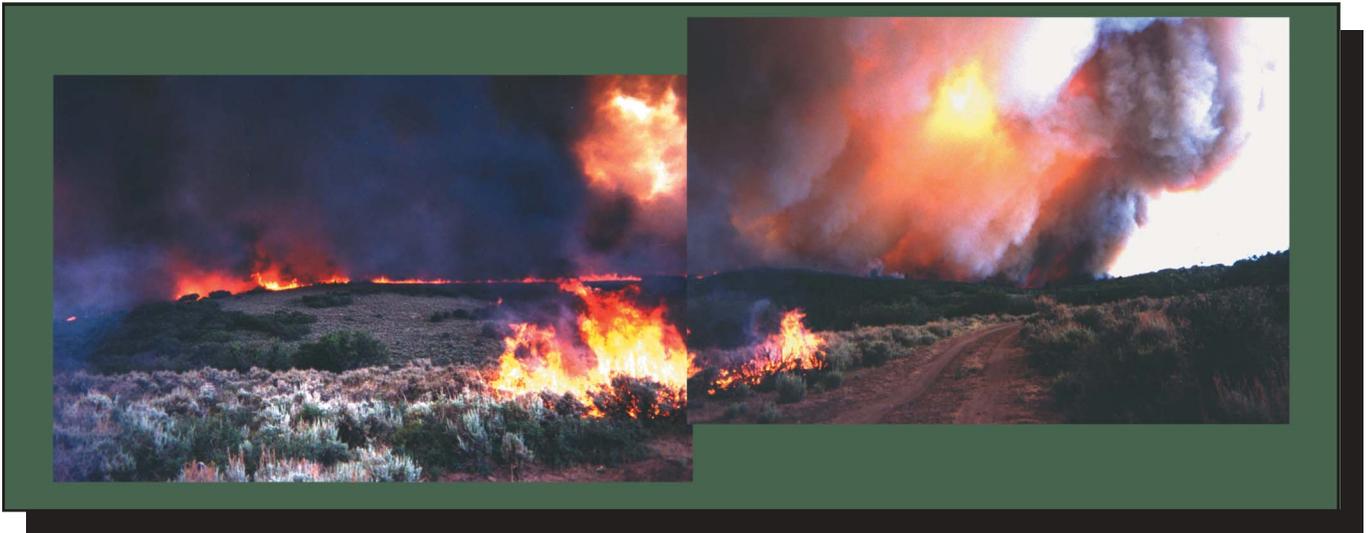
At about 1830, fire activity to the southwest of the jump spot was becoming increasingly threatening (figures 4 and 5). Loe, who had been firing the east road, returned to the jump spot because he ran out of fuses. JIC Orr instructed Loe to begin firing the south side of the road that headed west from the intersection.

Figure 4—Fire emerging onto the plateau from the west bowl. The fire in the foreground was the end of smokejumper Matt Loe's burnout west of the road intersection.

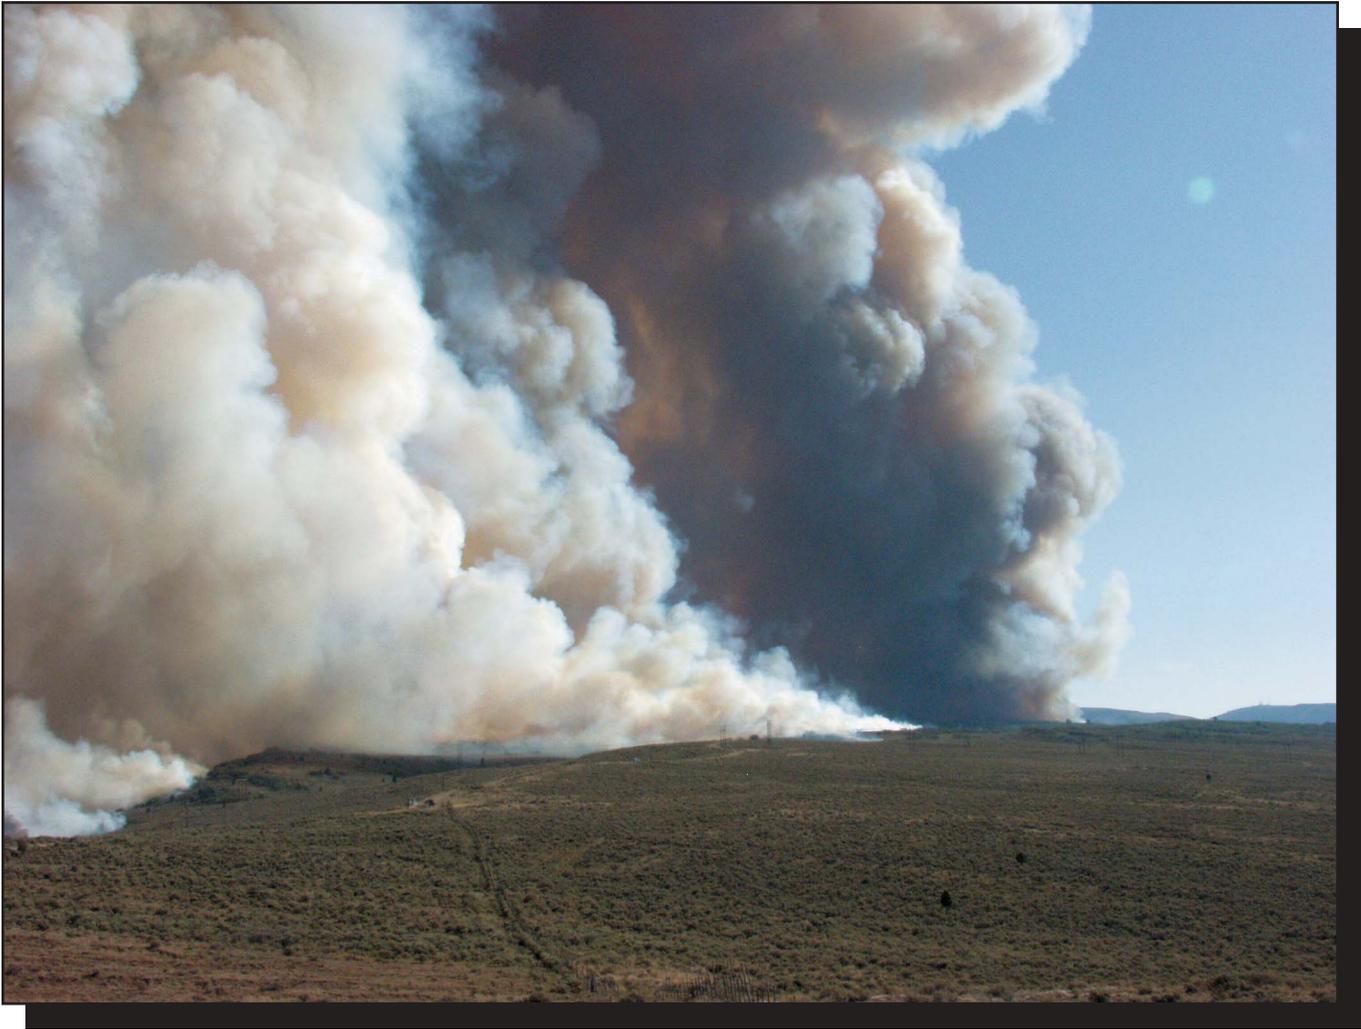
At about 1900, JIC Orr, Briant, Loe, Dwyer, and Burris were back at the jump spot. A dense, black smoke column was coming from the bowl (figure 6) and canyon rim to the southwest of them. The five jumpers could see that this part of the fire was advancing downhill in their direction and fire whirls were observed at this time. To prevent their jump gear

Figure 6—Column from the smokejumpers' firing operation (lighter smoke, left) and the fire column from the west bowl (darker, right).

At about 1900, the fire in the west bowl breached the rim of the canyon and began to burn onto the sagebrush plateau, igniting a line of fire about ½ mile long. As seen in figure 6, this fire is burning downhill toward the smokejumpers.

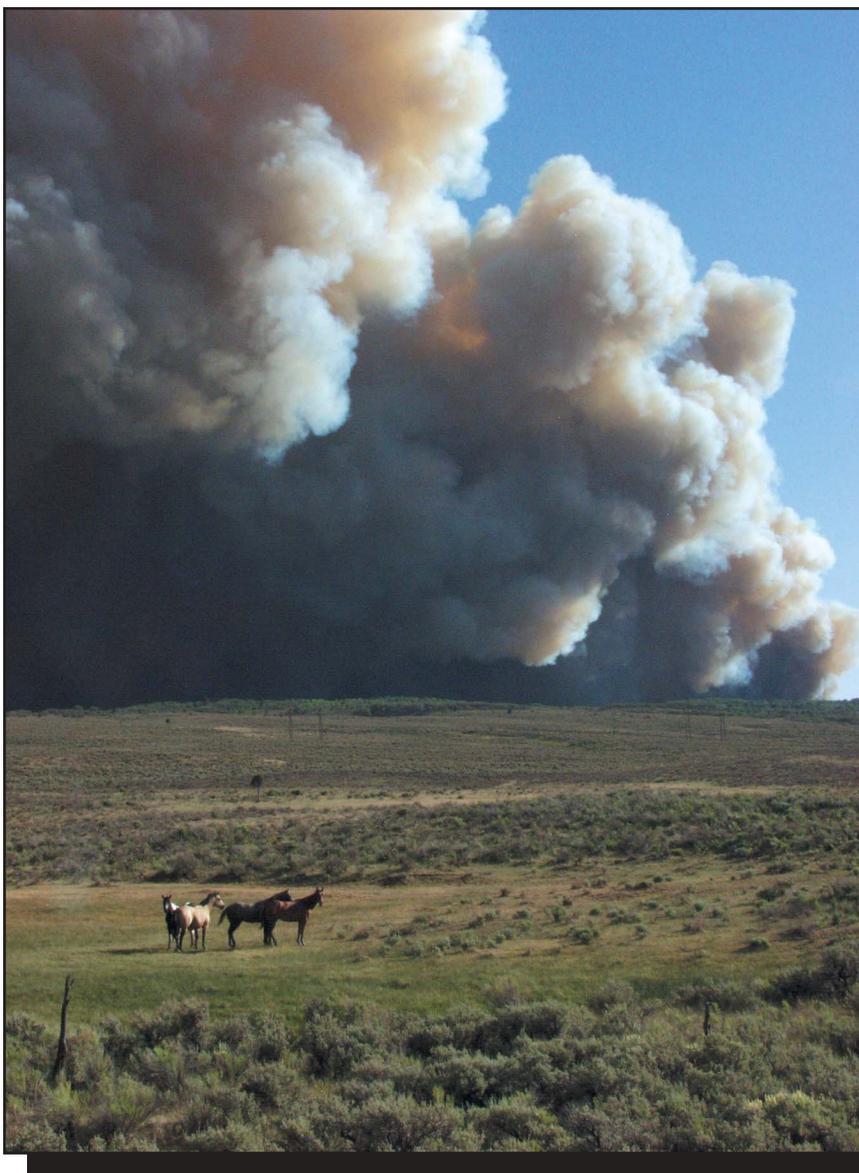
In a matter of seconds, the column from the bowl appeared to collapse on the five jumpers. Winds suddenly increased to an estimated 50+ miles per hour. What they described as a "river of fire" advanced toward them from the southwest. Dense black smoke enveloped the jumpers, and "softball-sized" debris and embers rained down around them (figure 7).

Figure 7—West end of the fire after column collapse.

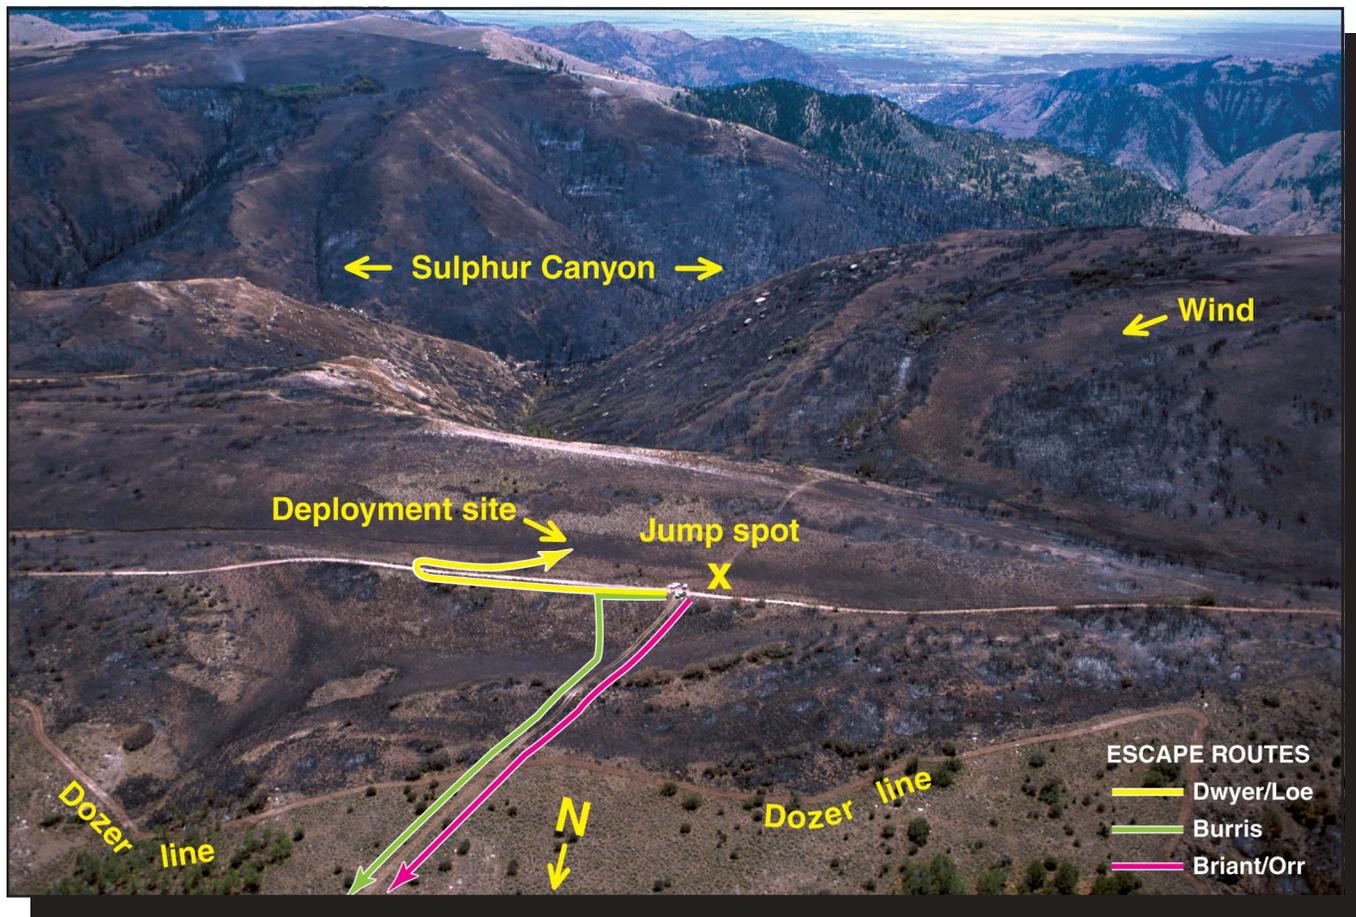
All five jumpers immediately began running. Dwyer and Loe ran toward the east down the two-track road that had been used as a control line for the firing operation (figure 8). After running for about 20 yards, Dwyer was forced to kneel for a moment so that he could catch a breath of clean air. Dwyer and Loe continued running, and soon the conditions became slightly less severe. They walked back toward the road intersection. By then, the fire was burning on the north side of the east-west road and visibility was extremely limited by the heavy smoke. They walked into the burned area on the south side of the road about 150 feet from the road intersection. After a brief discussion, they used their handtools to scrape an area to mineral soil and remove remnants of burning sagebrush. They deployed their fire shelters and got inside, each taking their radio and a canteen of water with them. Dwyer and Loe stated that they observed fire whirls and extreme, erratic fire behavior nearby.

Figure 8—Deployment site and escape routes.

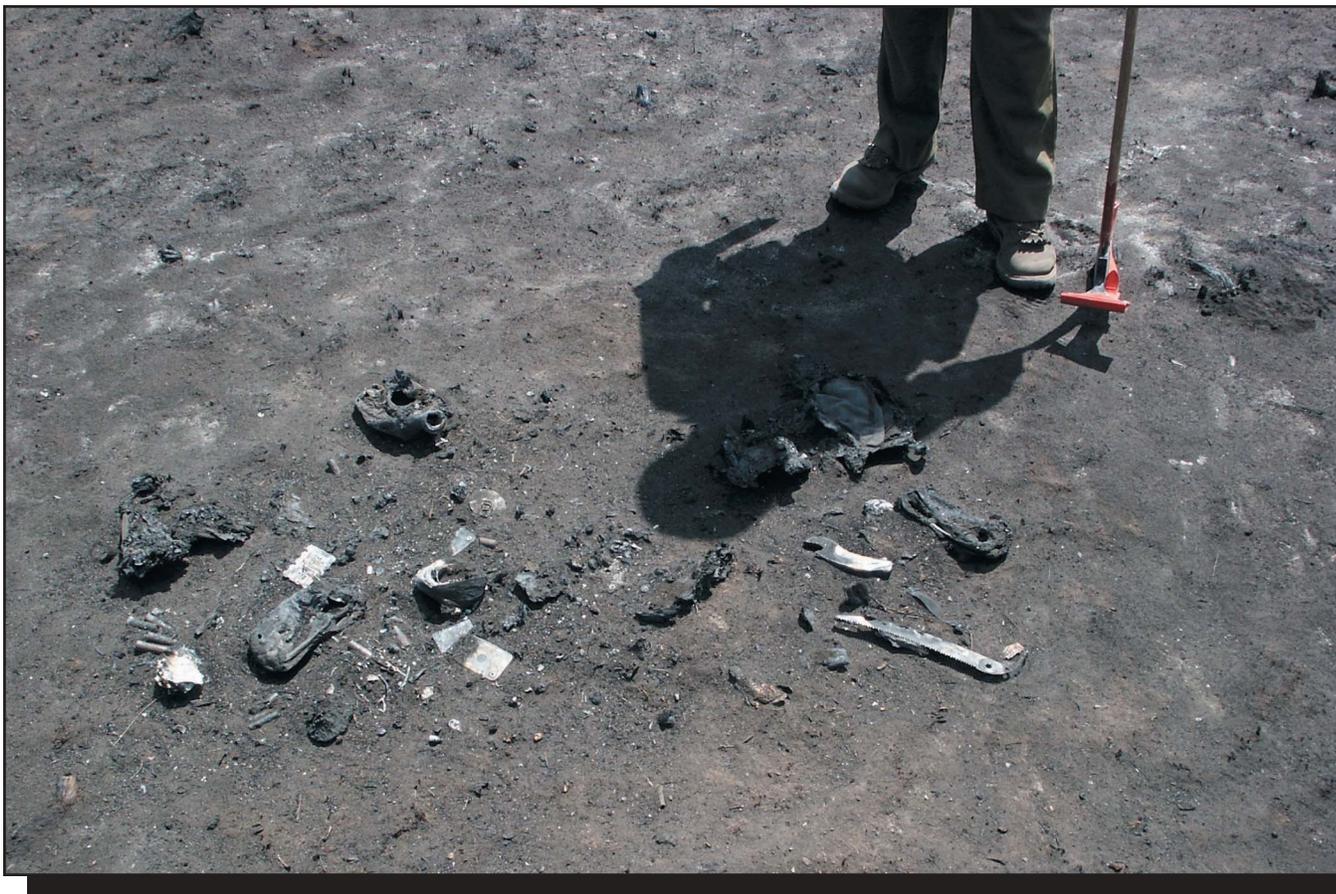
Figure 9—Remnants of smokejumper Burris' burned pack.

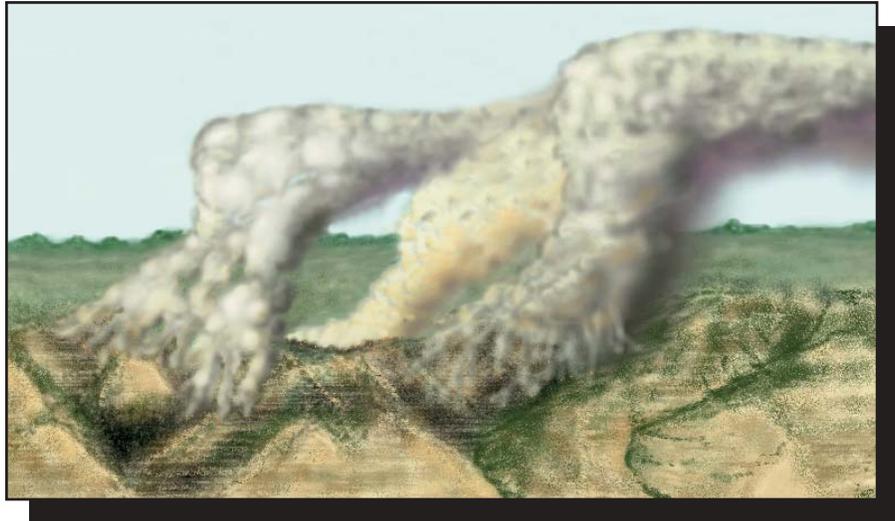
Figure 20—Artist rendering of the Price Canyon smoke columns.

Evidence indicates that the smokejumper entrapment was caused by the collapse of the west bowl smoke column. The hot air and gases from the collapsing column suddenly accelerated the ground fire on the plateau east of the rim, pushing the ground fire and hot air and embers toward the east.
