Executive Summary

On Sunday, June 30, 2002, a wildland fire was reported on Bureau of Land Management (BLM) land 14 miles northwest of Price, UT. The initial attack response included a type III incident commander, several fire engines, dozers, airtankers, a type III helicopter, and eight smokejumpers. When the incident commander (IC) and some of the engines arrived on the fire at about 1500, the fire was about 25 acres and growing rapidly. Extremely dry fuels, moderate winds, steep slopes, and deeply dissected drainages all indicated the potential for extreme fire behavior. It was determined afterward that a passing railroad train had started the fire.

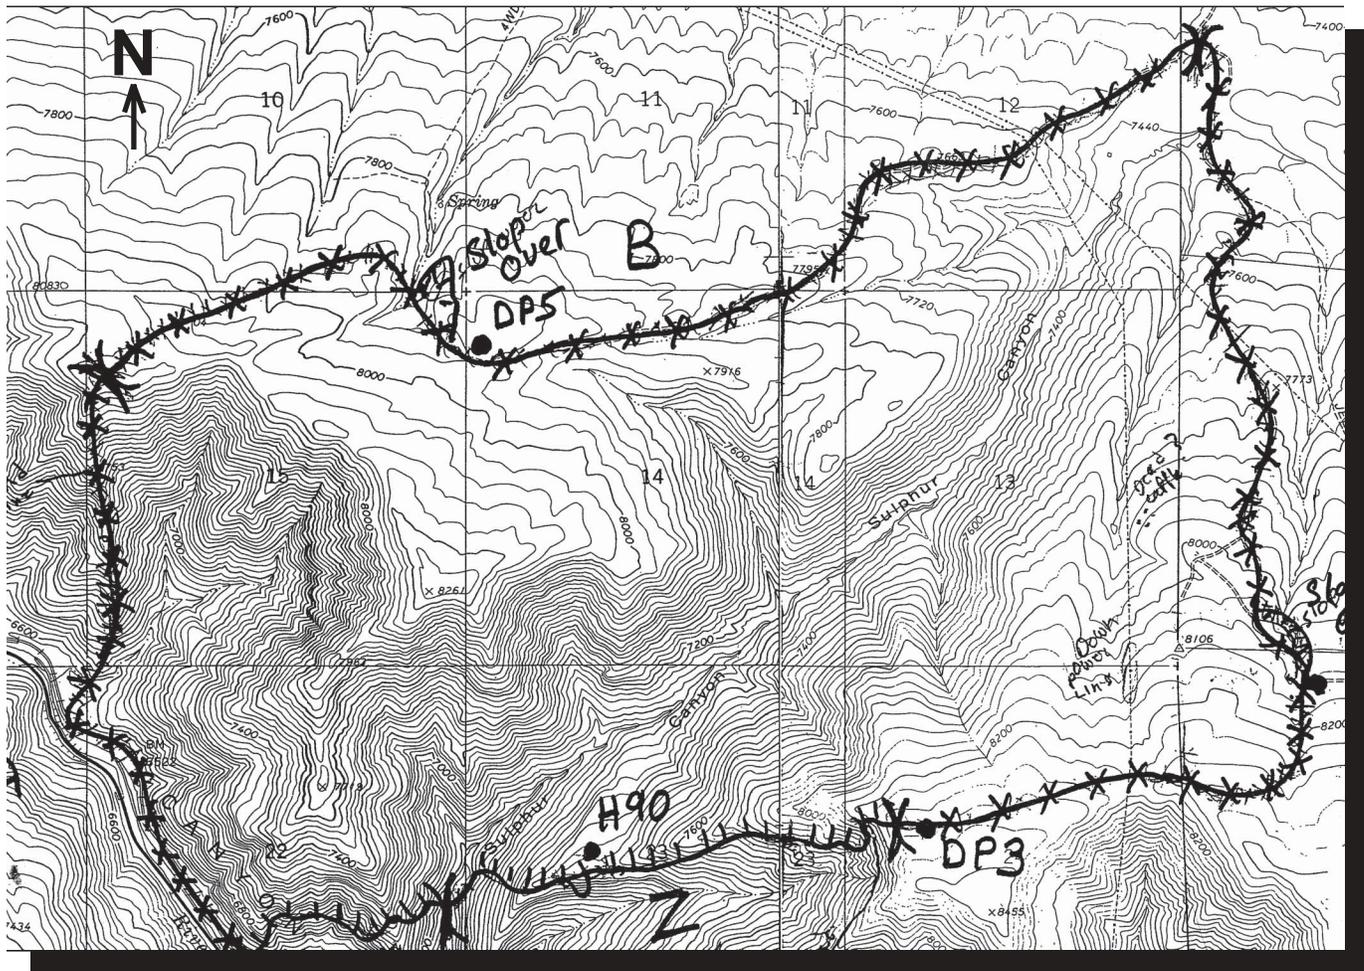
Figure 1—The Price Canyon fire terrain and perimeter .

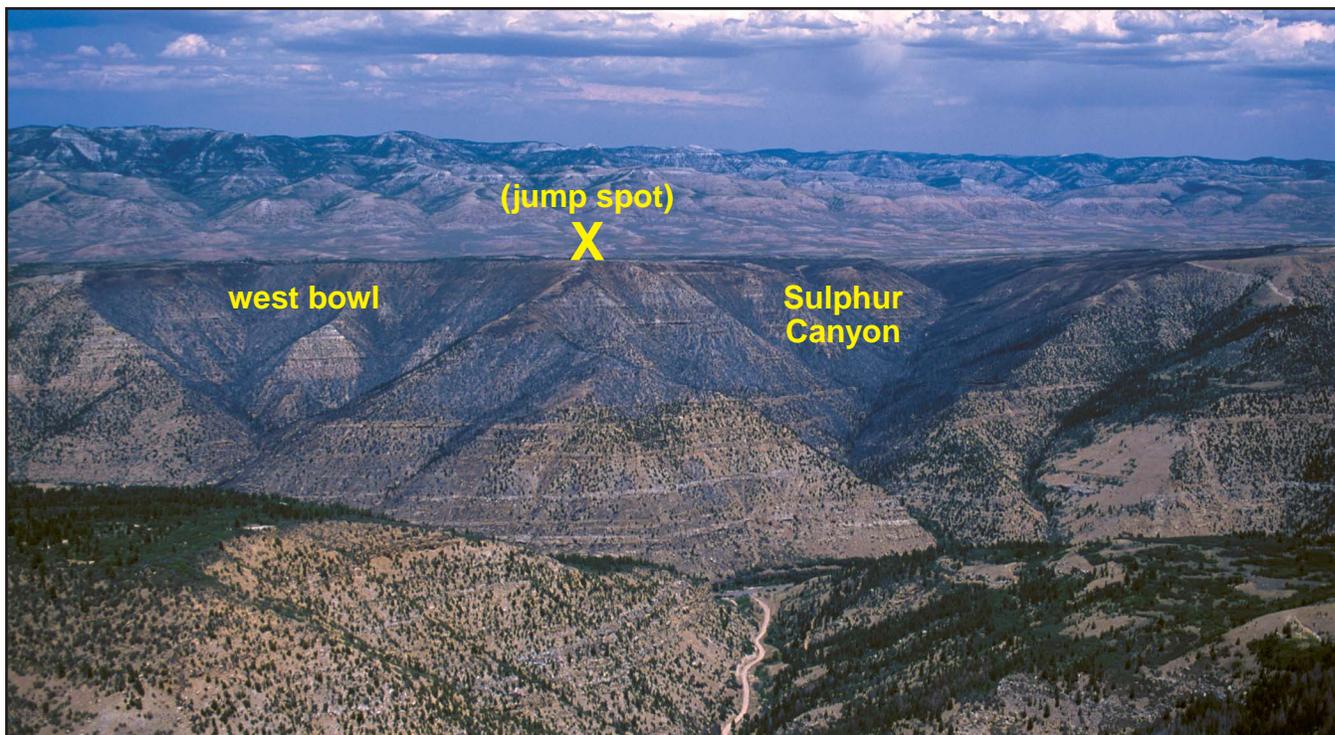
Figure 2—The west bowl and Sulphur Canyon.

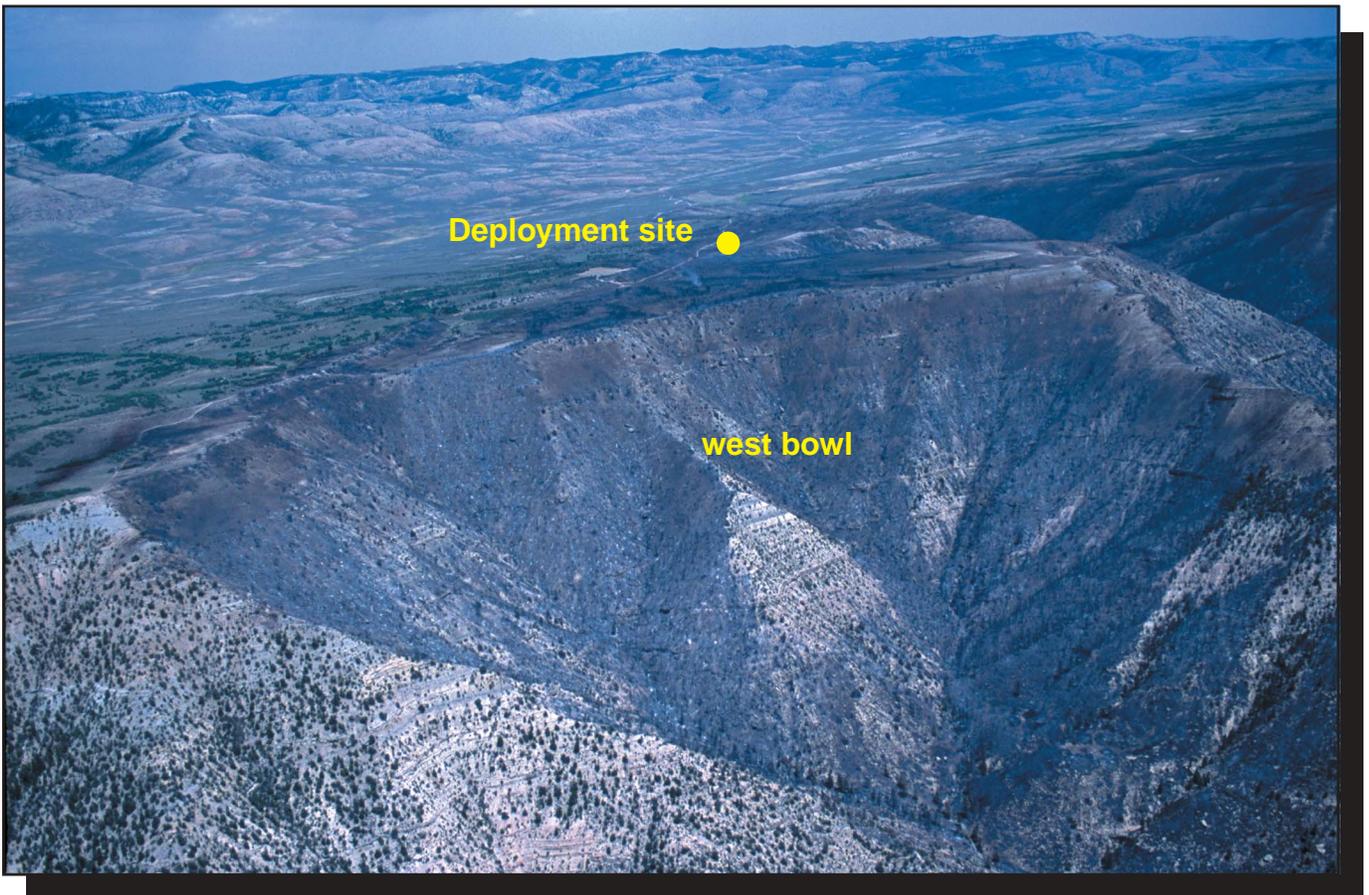
At about 1830, fire activity to the southwest of the jump spot was becoming increasingly threatening (figures 4 and 5). Loe, who had been firing the east road, returned to the jump spot because he ran out of fuses. JIC Orr instructed Loe to begin firing the south side of the road that headed west from the intersection.

Figure 5—West bowl, plateau, and deployment site.

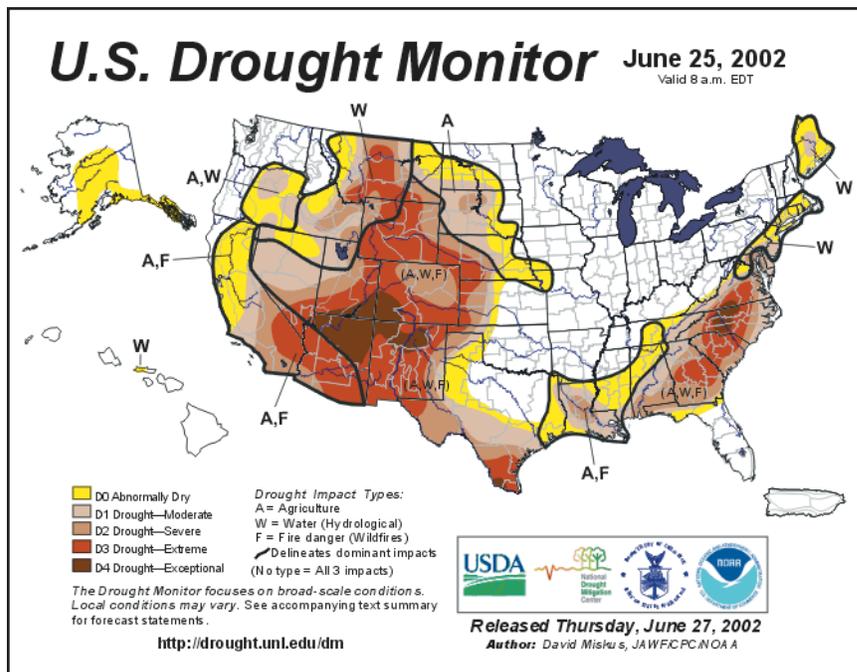
Southeastern Utah had been in an extended drought. The Price Canyon fire area was classified as being in a "severe-to-extreme drought." The Palmer drought index indicated that 2002 was one of the severest droughts in Utah since 1895. The U.S. Drought Monitor report for June 25, 2002 (figure 10), typed Price, UT and the surrounding area as being in an "exceptional drought."

Figure 10—U.S. Drought Monitor map, June 25, 2002.

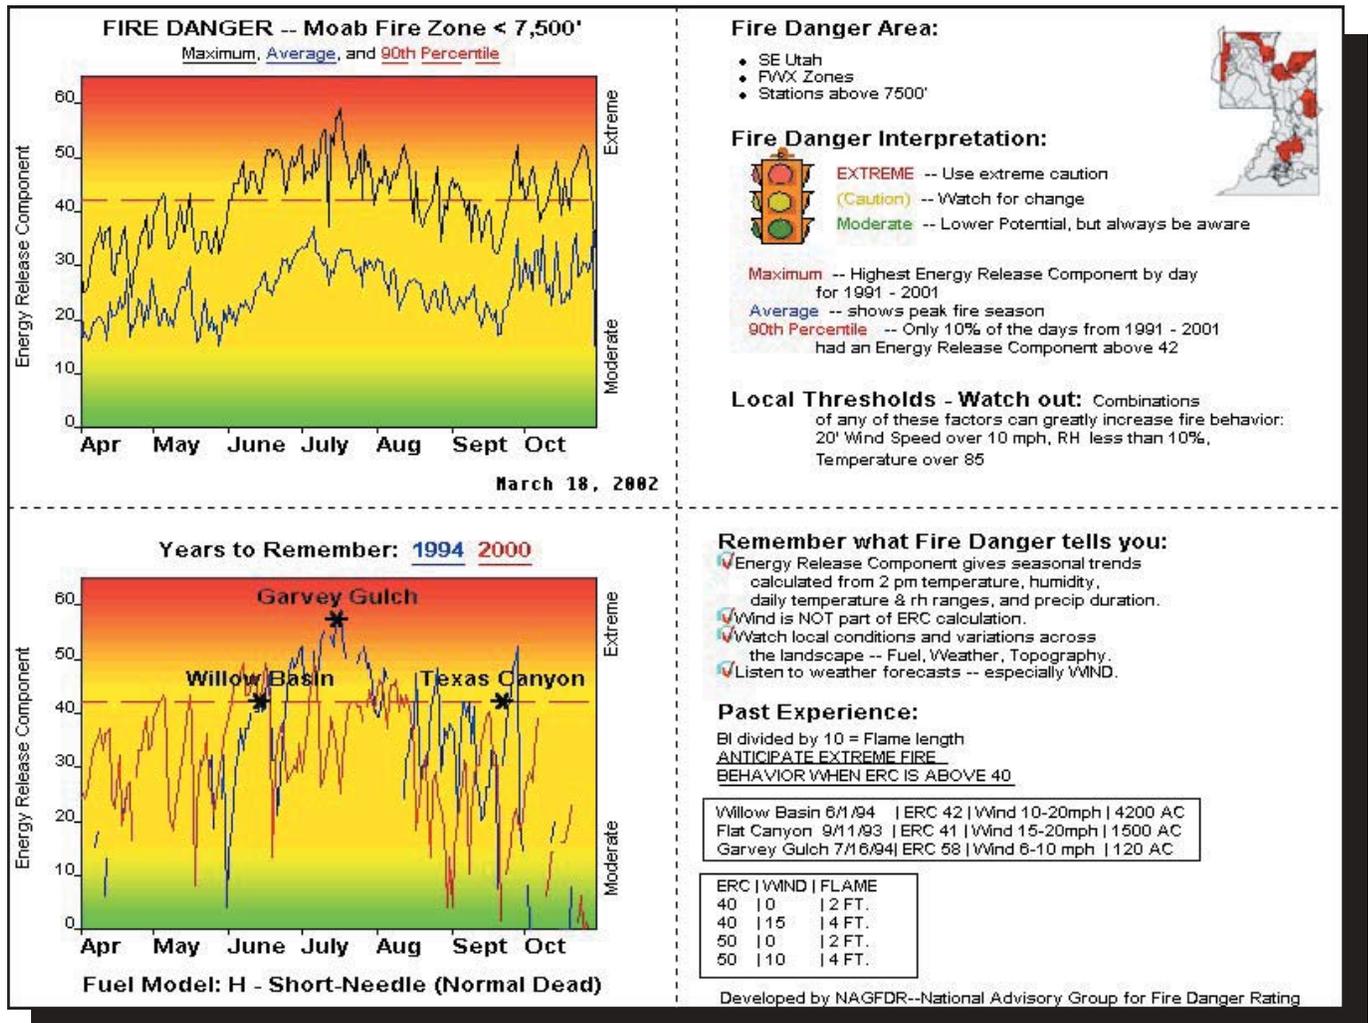
Figure 16 shows the fire danger pocket card for the energy release component for fuel model H used in southeastern Utah. A similar card for fuel model F was issued by Moab dispatch. The card is for general firefighter use, and is generally used when briefing initial attack firefighters before they are dispatched to a fire. The card is used for risk assessment, linking fire danger to potential fire behavior.

Figure 16—Fire danger pocket card.

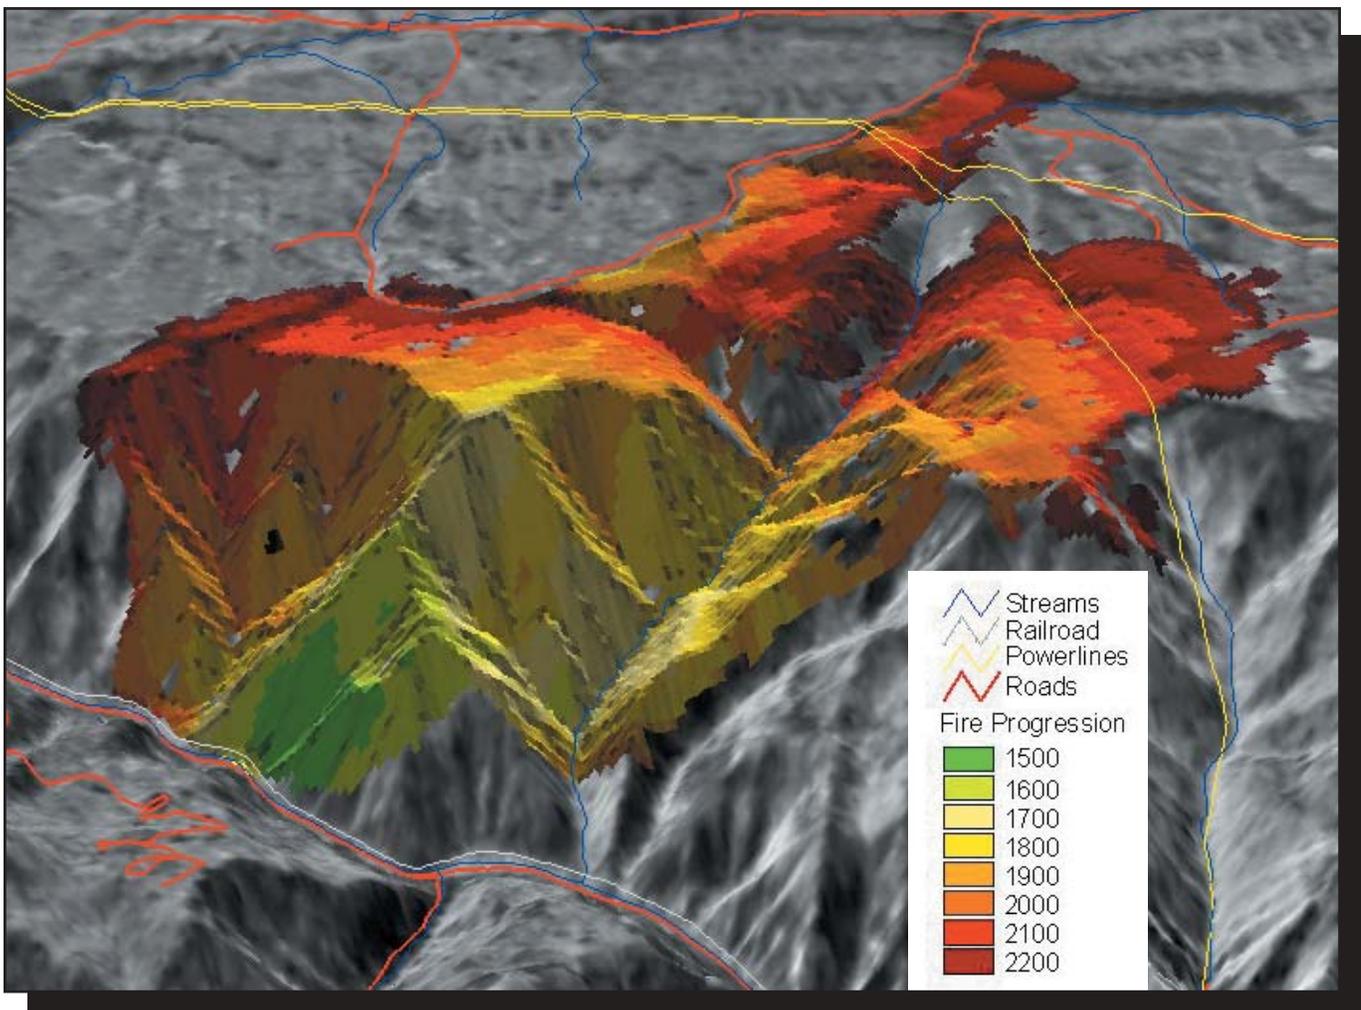
A geospatial fire behavior prediction was made using the FARSITE computer model (figure 19). The fire's spread was calculated from 1500 to 2200 hours on June 30.

Figure 19—FARSITE computer model predicting the fire's spread from 1500 to 2200 on June 30, 2002.
