United States Department of the Interior  
Serious Accident Investigation Report

David J. Liston  
Smokejumper Fatality

Thomas O. Roach  
Smokejumper Non-injury  
Parachute Malfunction

Bureau of Land Management  
Alaska Fire Service  
Ft. Wainwright, Alaska

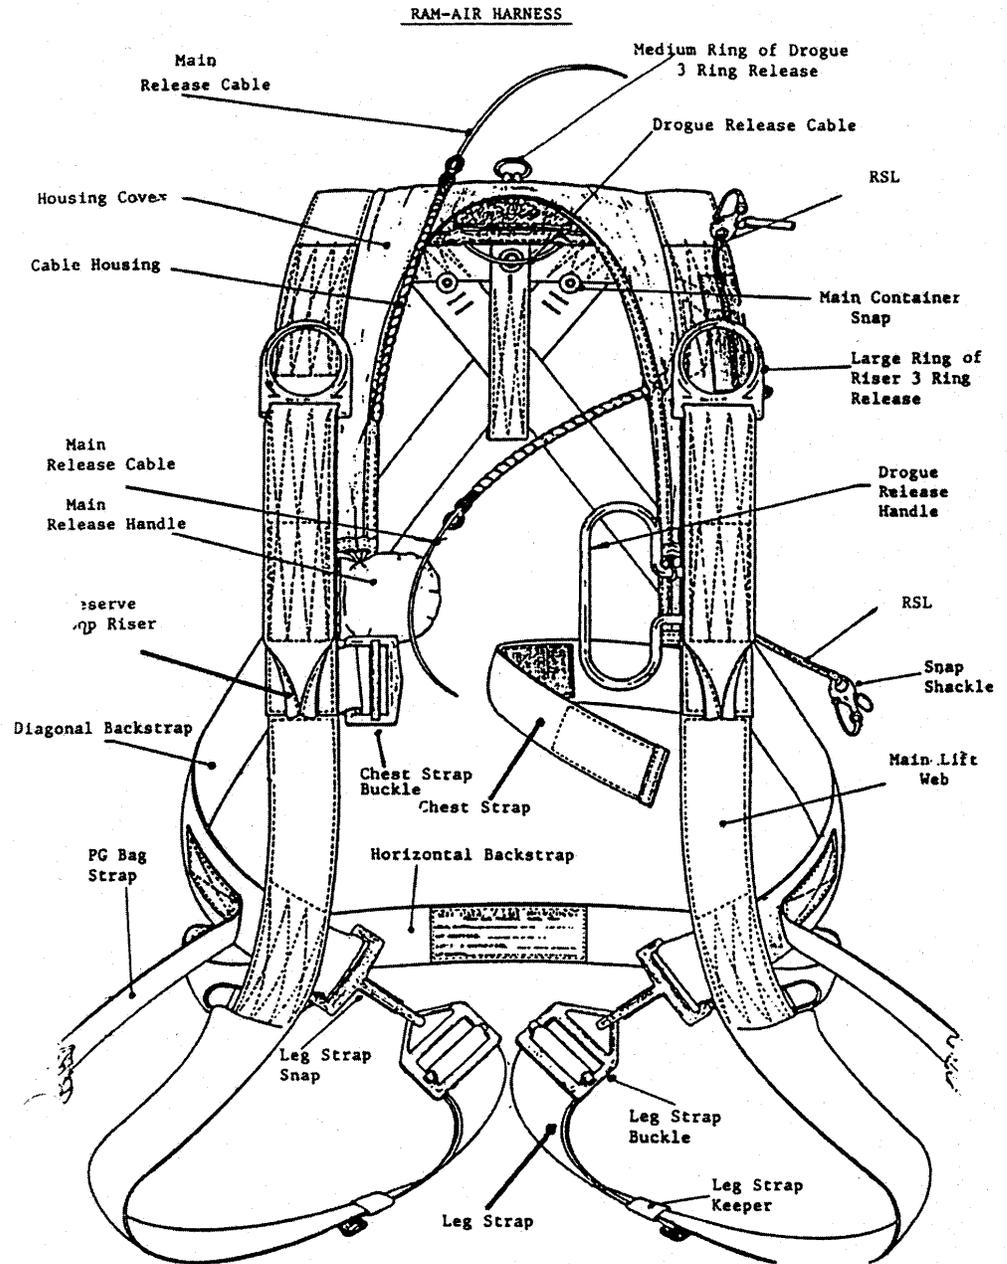
Model 8801 Ram-Air Harness

Model 8801 Ram-air HARNESS

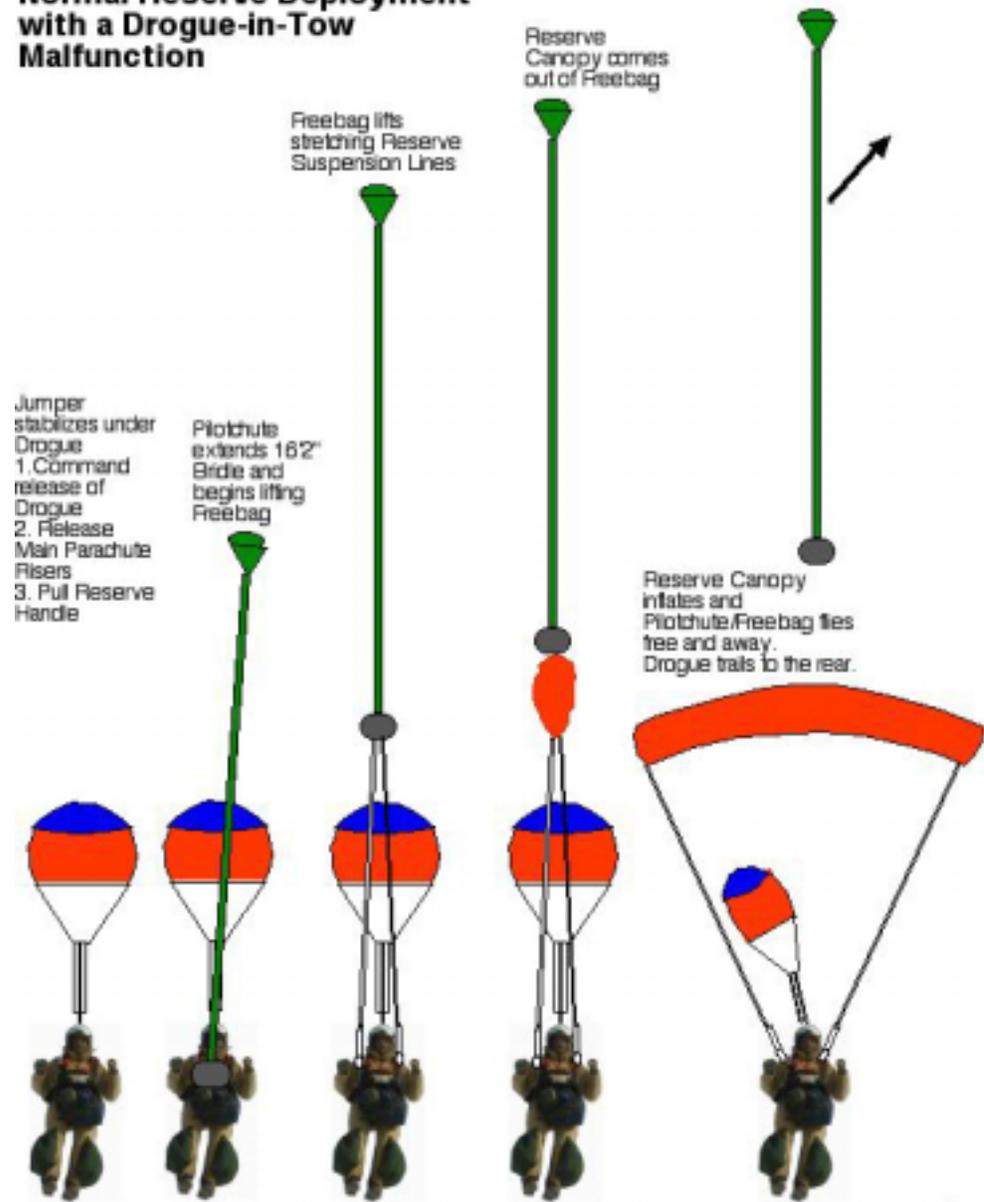
**Normal Reserve Deployment with a Drogue-in-Tow Malfunction**

Normal Reserve Deployment with Drogue-in-Tow Malfunction

The evidence shows that Roach's drogue parachute deployed but the main parachute did not deploy when he pulled the drogue release handle. Roach recognized the malfunction as a drogue-in-tow (failure of the main parachute to deploy). He then initiated his emergency procedures, pulled his main release handle and his reserve parachute handle. The reserve parachute deployed. As it did, the drogue released and the main detached from the harness. He landed without further incident.

The BLM *Ram-air Training Manual - 2000* identifies the following causes of a drogue-in-tow malfunction (when the drogue deployed but did not release as designed):

- 3-rings not hooked up correctly;
- wrong cables used to hook drogue;
- swedge came loose on drogue release handle; and,
- drogue bridle breaks.
